great lakes shoreline damage survey

saint louis county, minnesota

APPENDIX I

4. TITLE (and Subtitle) Summary Report of the Pilot Study Program, Great Lakes Shoreland Damage Study, (nine volumes, see reverse side) Appendix I. Great Lakes Shoreline Damage Survey; St. Louis County, Minnesota		5. TYPE OF REPORT & PERIOD COVERED Final July 1973-July 1974

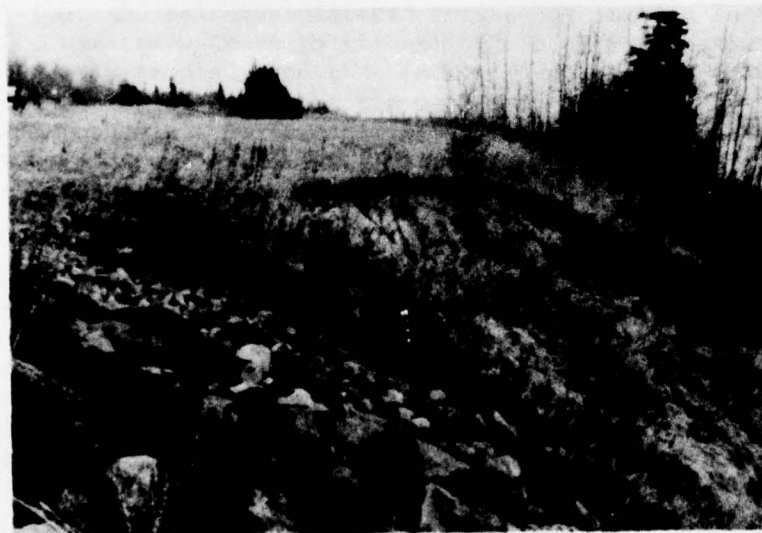
Figure B-10 Erosion and slump of bluff materials adjacent to old U.S. Highway 61 (North Shore Drive). Although critical problems such as this exist elsewhere on the Great Lakes, the intensity and frequency of such conditions on Lake Superior are just approaching the serious proportions of its smaller counterparts.

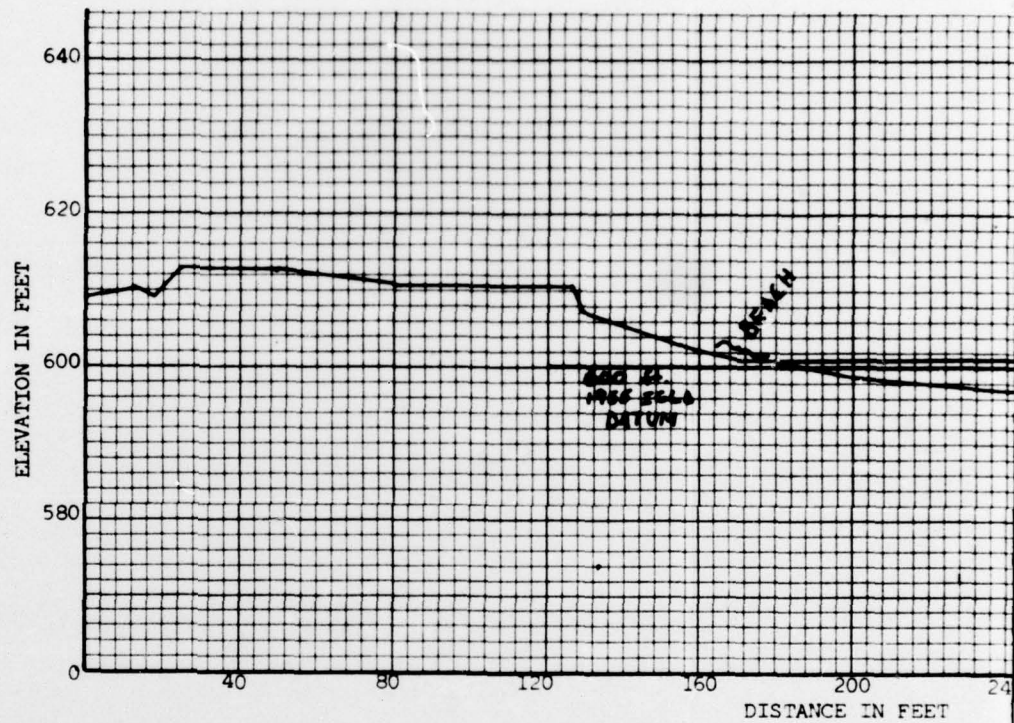
PARK POINT SITE
REACH 3-PROFILE 5
JUNE 3, 1975
